FINAL REPORT
FOR
MARCORSYSCOM

LOGISTICS VEHICLE SYSTEM (LVS) SIGNATURE DATA

NATC PROJECT NUMBER 20513
DECEMBER 2002 - JANUARY 2003

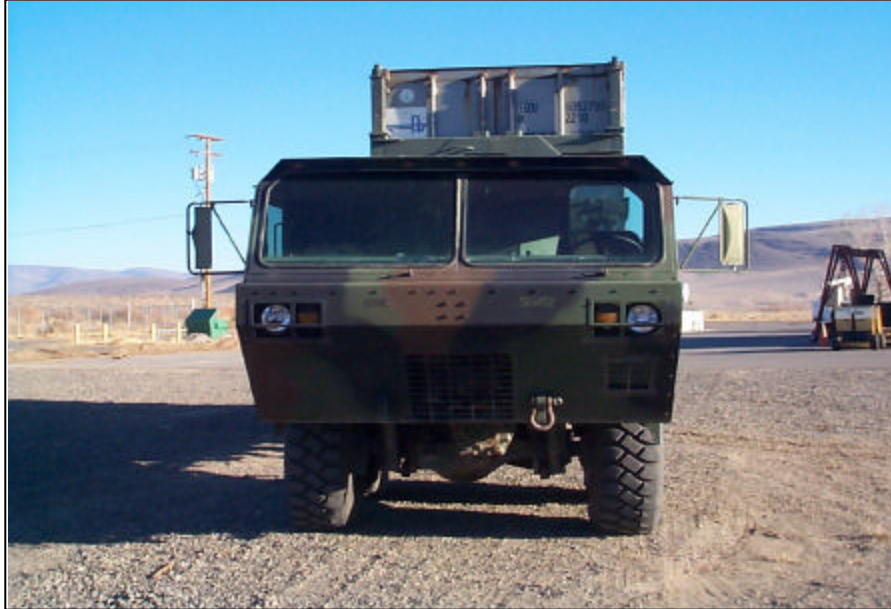
VISUAL IMAGE VEHICLE FRONT

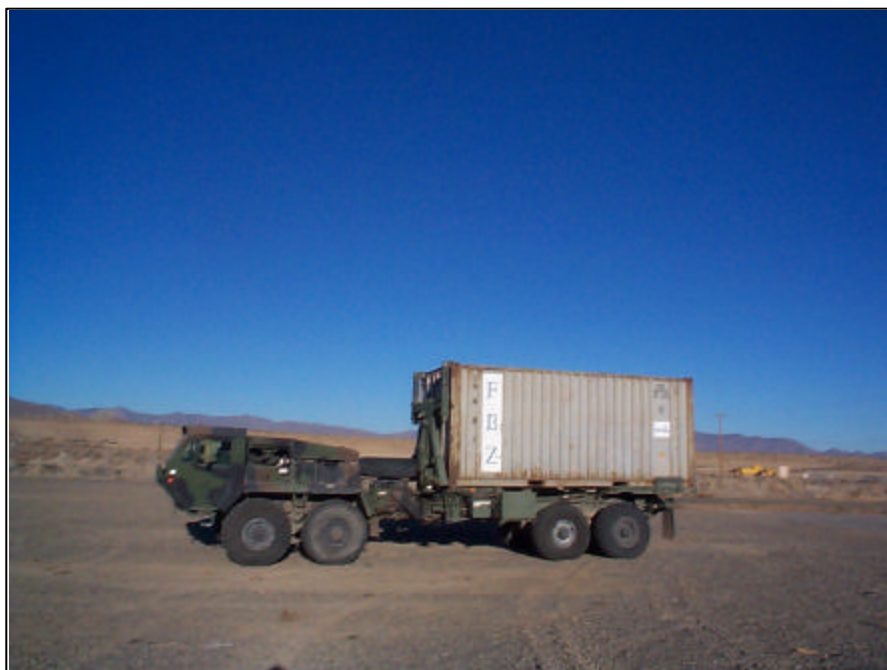
VISUAL IMAGE VEHICLE DRIVER SIDE

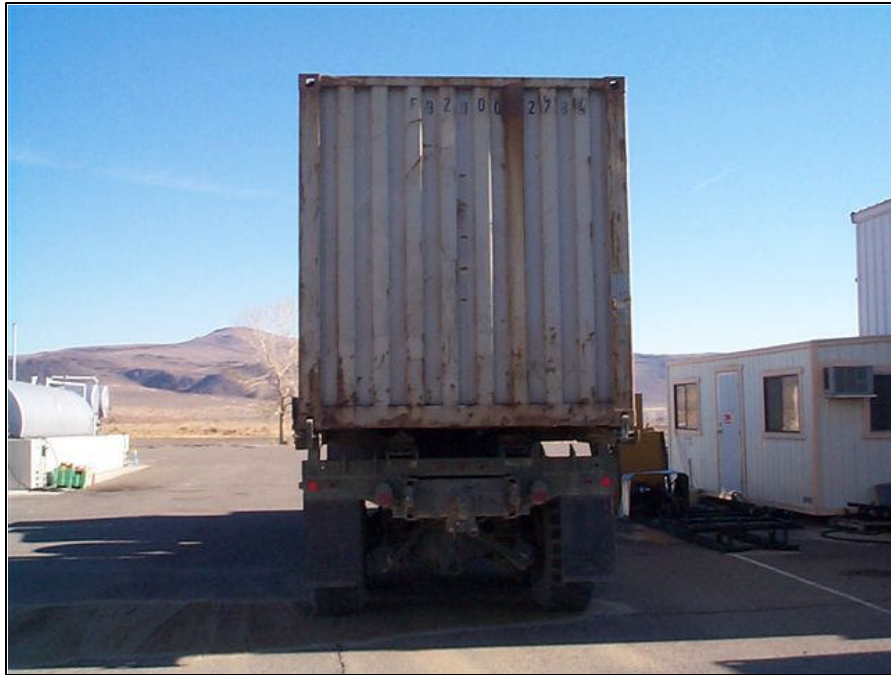
VISUAL IMAGE VEHICLE REAR

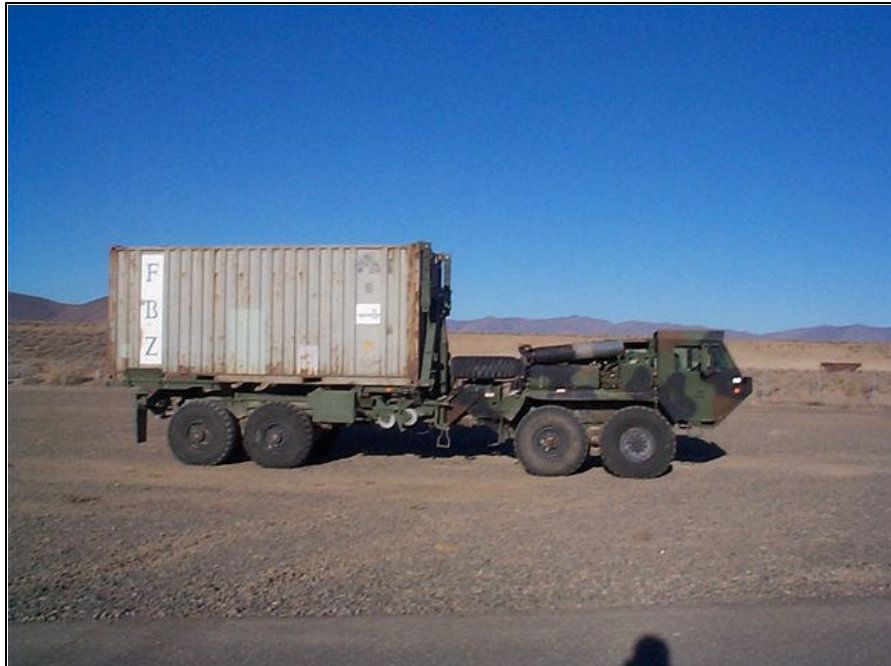
VISUAL IMAGE VEHICLE PASSENGER SIDE

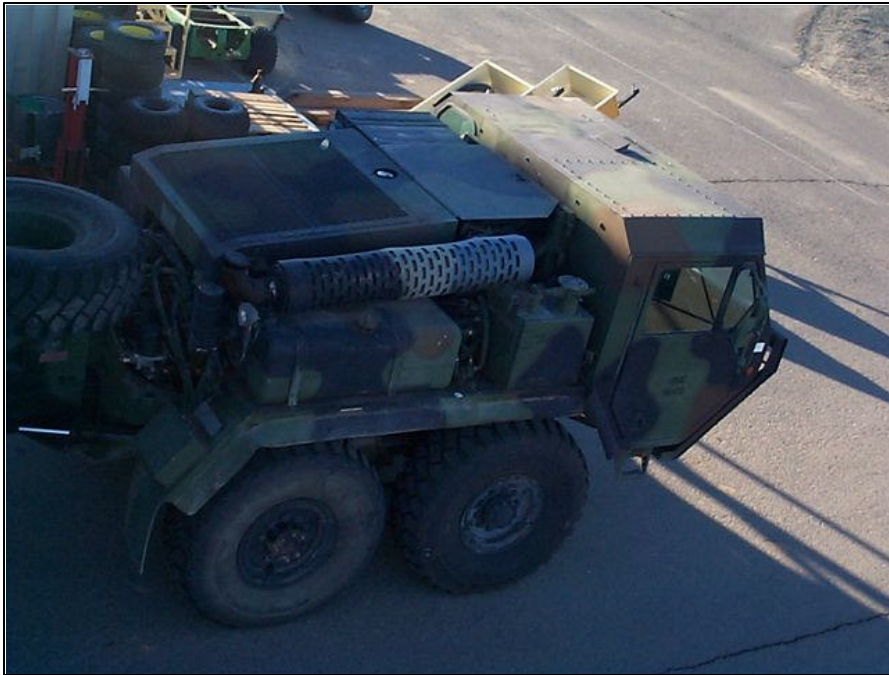
VISUAL IMAGE VEHICLE AERIAL VIEW
